STEPHEN FOSTER DAM

NDS ID NO. PA-906
DER ID NO. 8-59

PHASE I INSPECTION REPORT NATIONAL DAM INSPECTION PROGRAM

JUNE, 1979

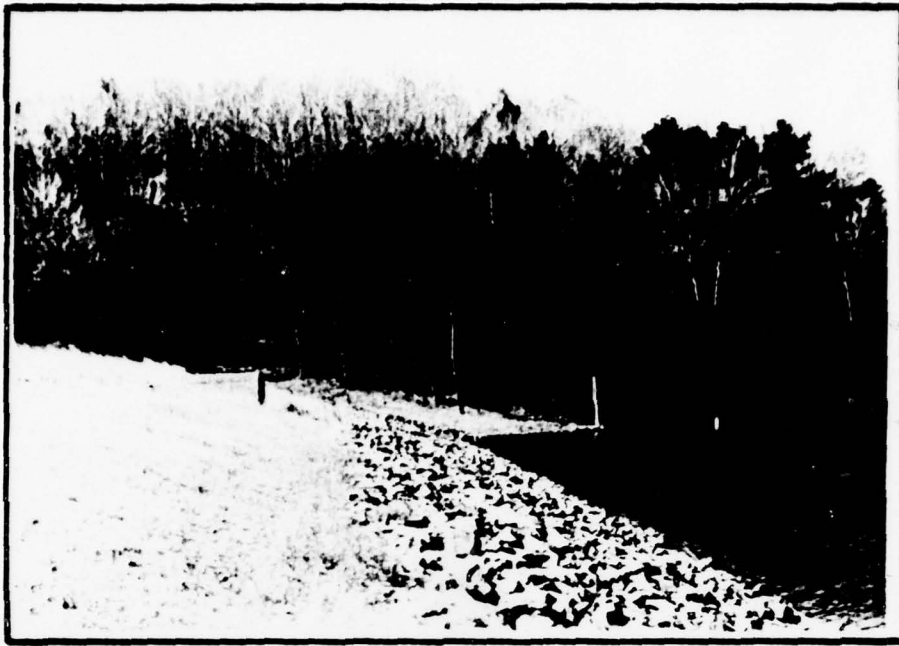
Upstream slope and drain control structure from left abutment.

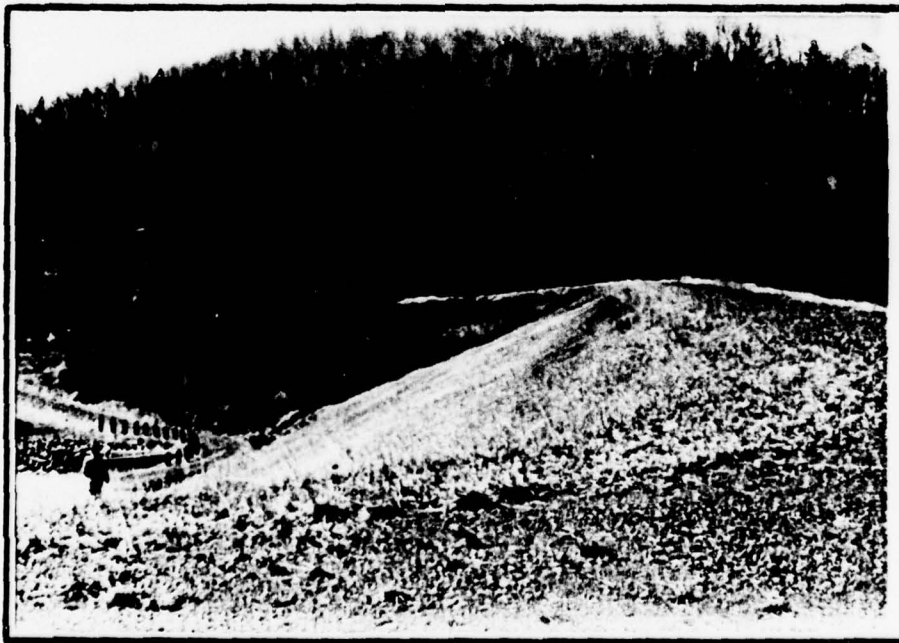
Downstream slope from spillway area.

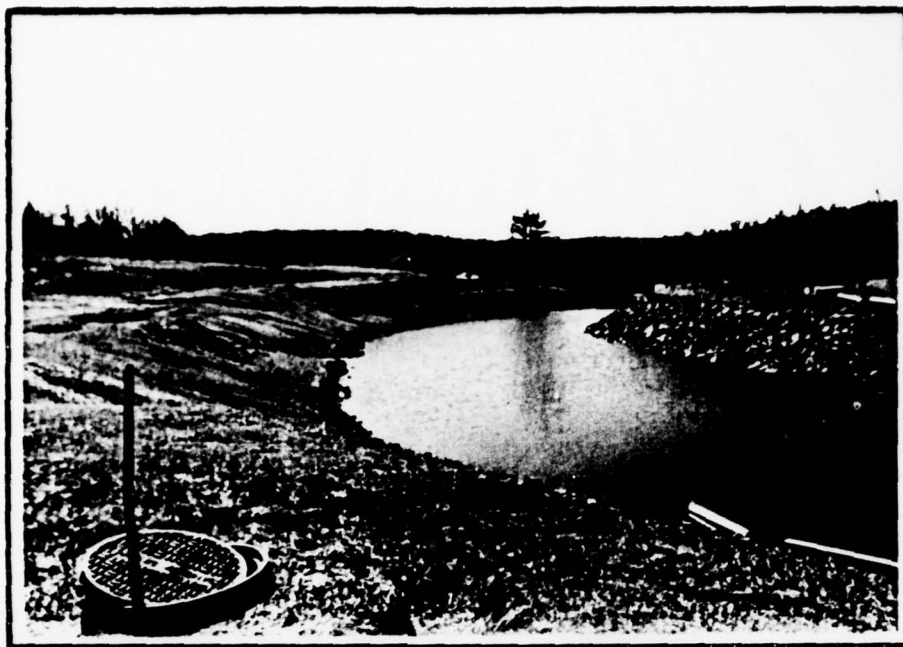
c. Visual Observations. The concrete in the spillway and spillway discharge channel is in good condition. The cut slope on the left spillway approach channel contains several active slides. These slides have approximately 1 to 3 feet vertical displacement and approximately 8 feet horizontal displacement. The slides are moving toward the spillway approach channel. A large slide in this area could partially block the spillway approach channel. Several slides have taken place to the left of the spillway discharge channel. The moving of this hillside has caused the left wingwall near the spillway weir to move and a joint has opened approximately 1.5 inches wide.

Spillway approach channel.
Note: slides on left abutment.

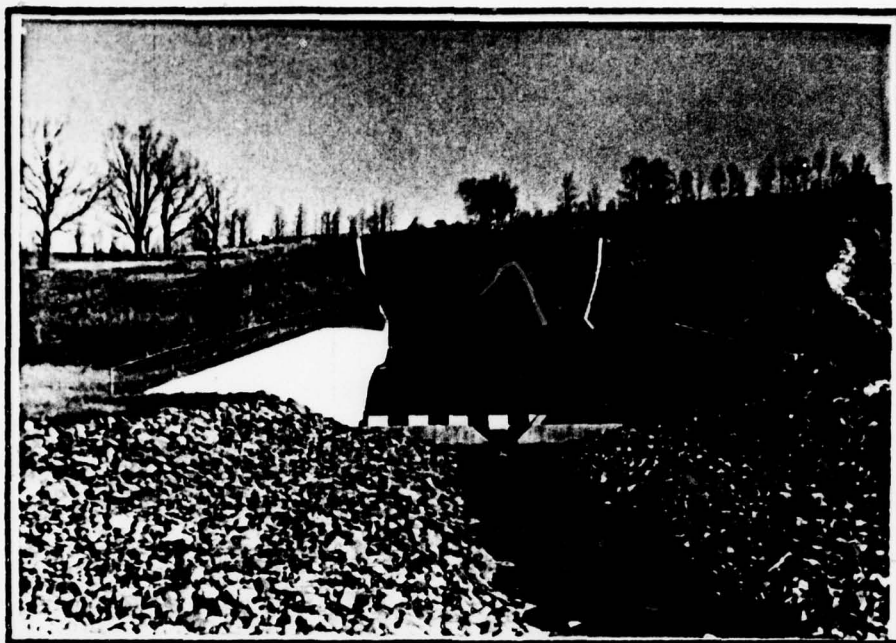
Spillway exit channel.

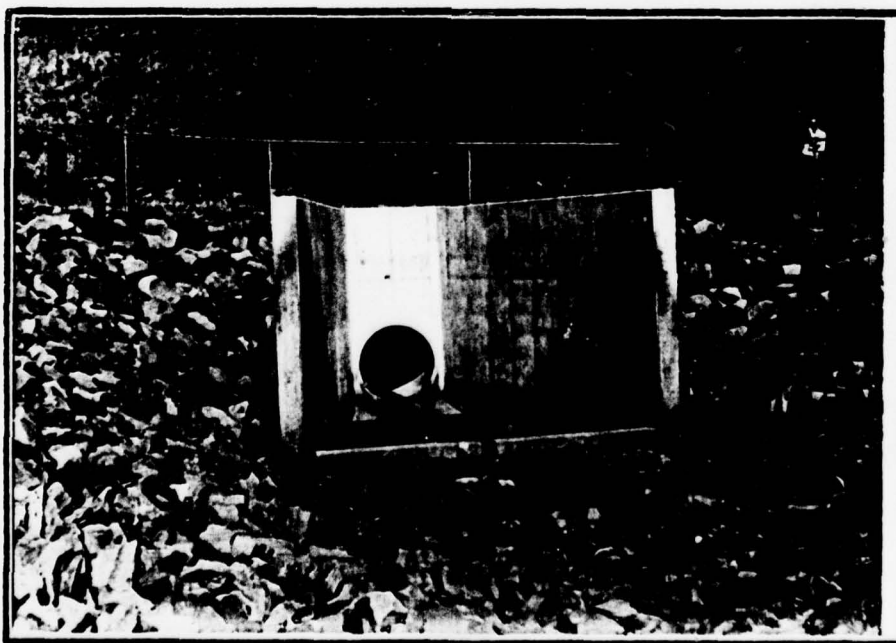
The 48" drainline was not operated during the inspection, however concrete at the outlet end appeared to be in good condition. The control structure was opened for inspection. The handles to operate the 48" drawdown conduit are not kept at the dam but are kept at the park superintendent's office.

Endwall on reservoir drain.

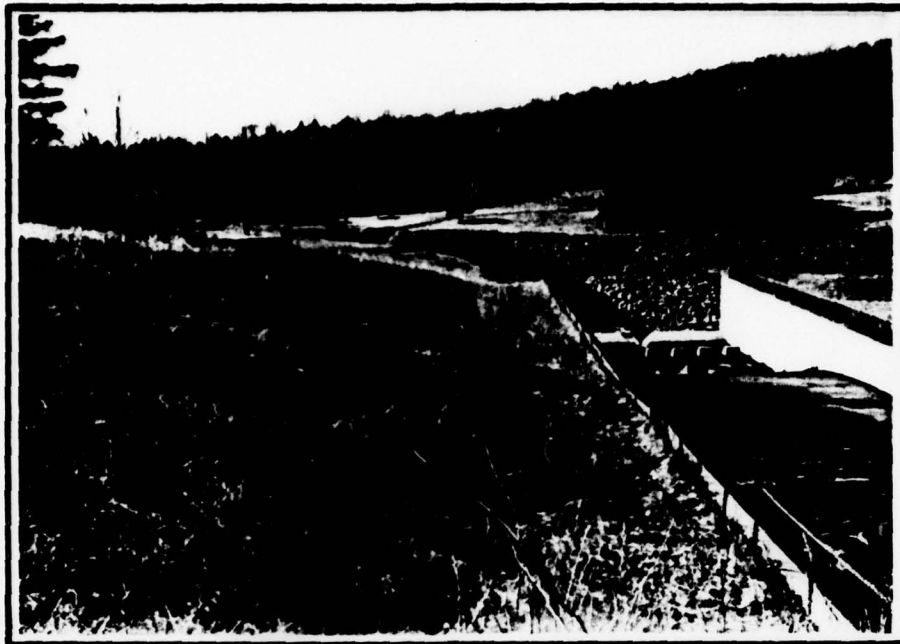
Immediate downstream view.
Note: slides to left of spillway exit channel.

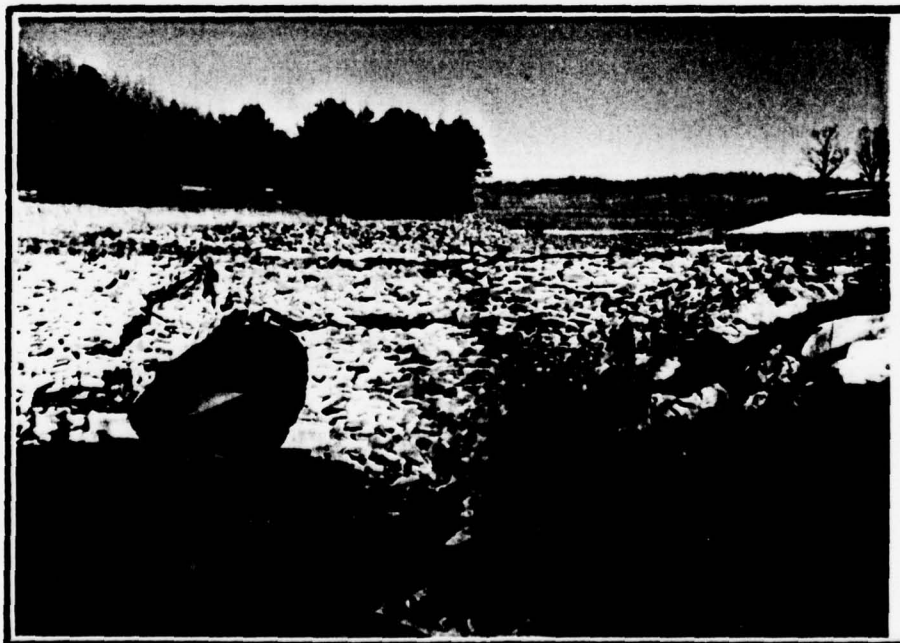
VISUAL EXAMINATION OF	OBSERVATIONS	REMARKS OR RECOMMENDATIONS
CONDITION (OBSTRUCTIONS, DEBRIS, ETC.)	Narrow to moderately wide. Immediately below dam is an access road culvert which was destroyed during recent high discharges. This culvert and roadway were overtopped and the slope has failed.	
SLOPES	Stable.	
APPROXIMATE NO. OF HOMES AND POPULATION	Approximately five homes and the Bradford County Home and Hospital within 3.5 miles of the toe of the dam. Approximately 100 people live within this region.

Damaged access road crossing.

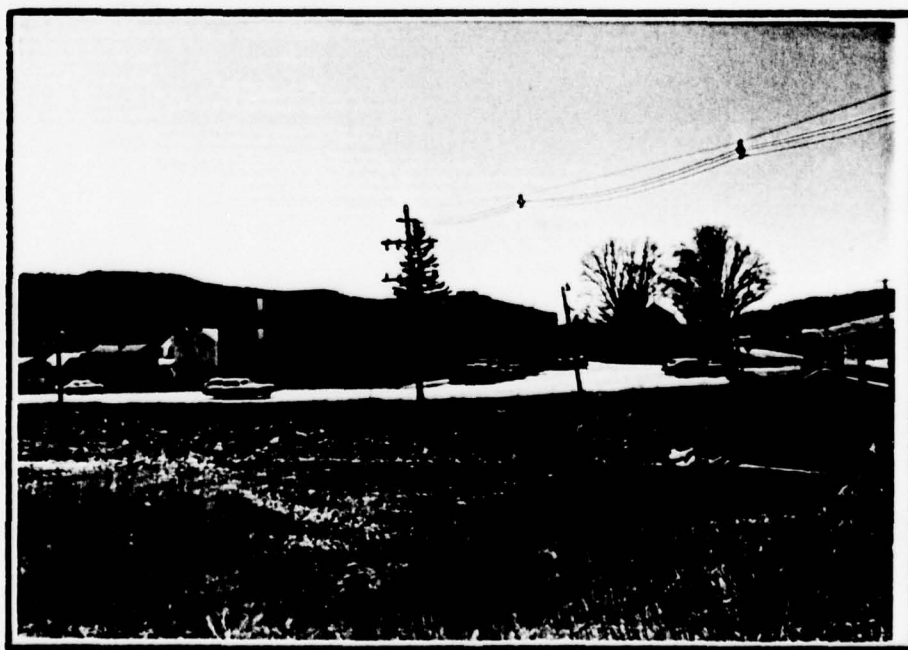
Homes and hospital downstream.
